Destructive Single-Event Effects in Diodes

Megan C. Casey¹, Jean-Marie Lauenstein¹,
Michael J. Campola¹, Edward P. Wilcox², Anthony M. Phan²,
and Kenneth A. LaBel¹

¹NASA Goddard Space Flight Center

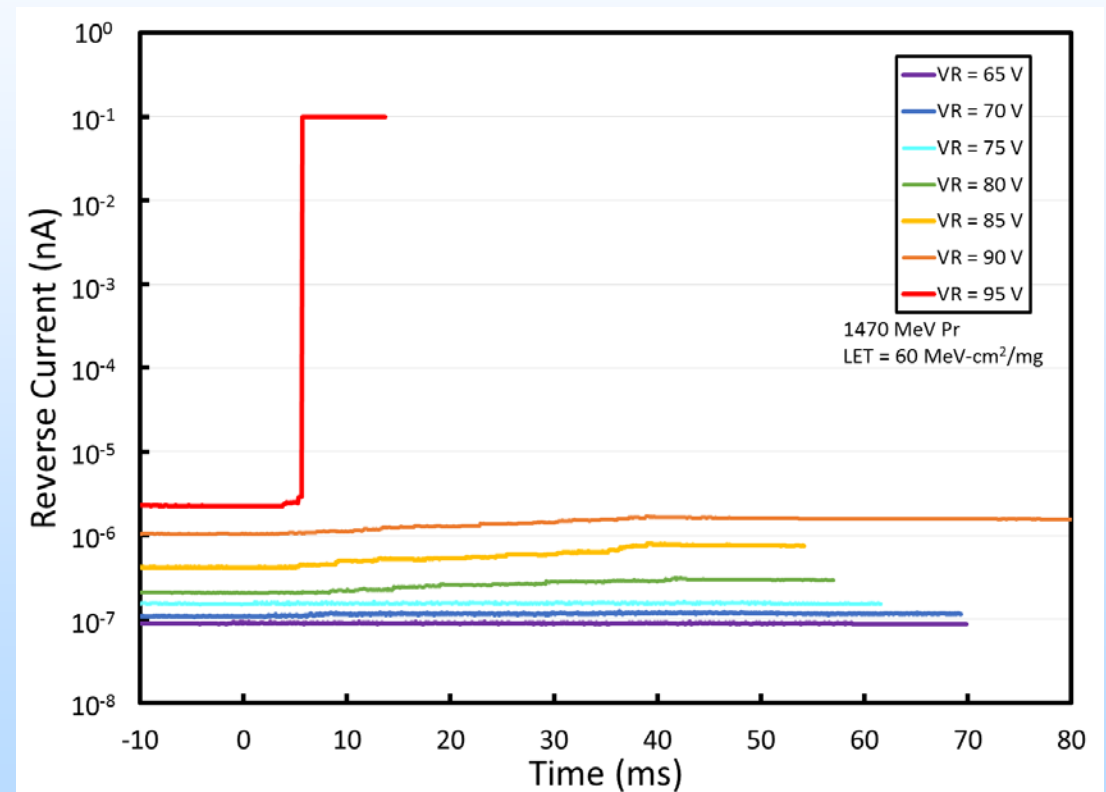
- SN5 was irradiated with 1470 MeV Pr (LET = 60 MeV-cm²/mg) in 5 V steps starting at 50 V (50% of the rated reverse voltage)
- Only charge collection was observed up to the 65-V irradiation
- When biased at 70 V, small increases in the reverse current were observed during the beam run
 - Post-irradiation electrical parameter measurements all remained within specification
 - Increases in reverse current were on the order of 100 nA
- At 95 V, the increase in reverse current was 100s of nA

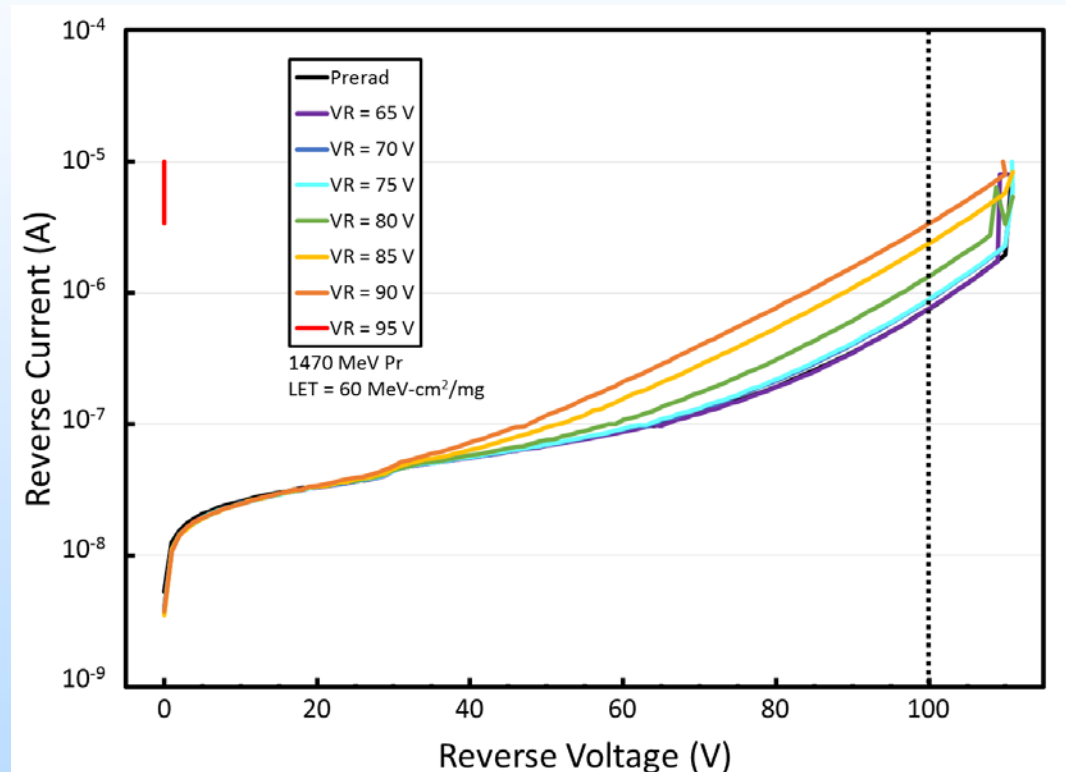
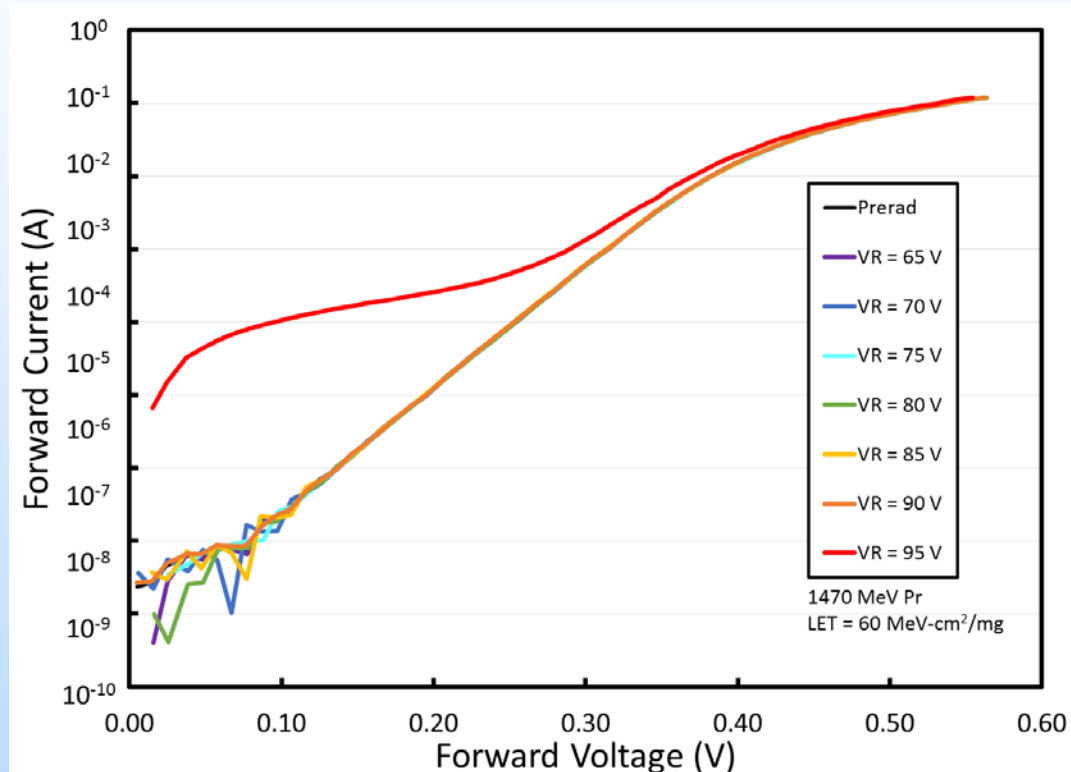
Part was degrading until after the 95-V run, and then I_R exceeded 10 μ A at less than 1 V

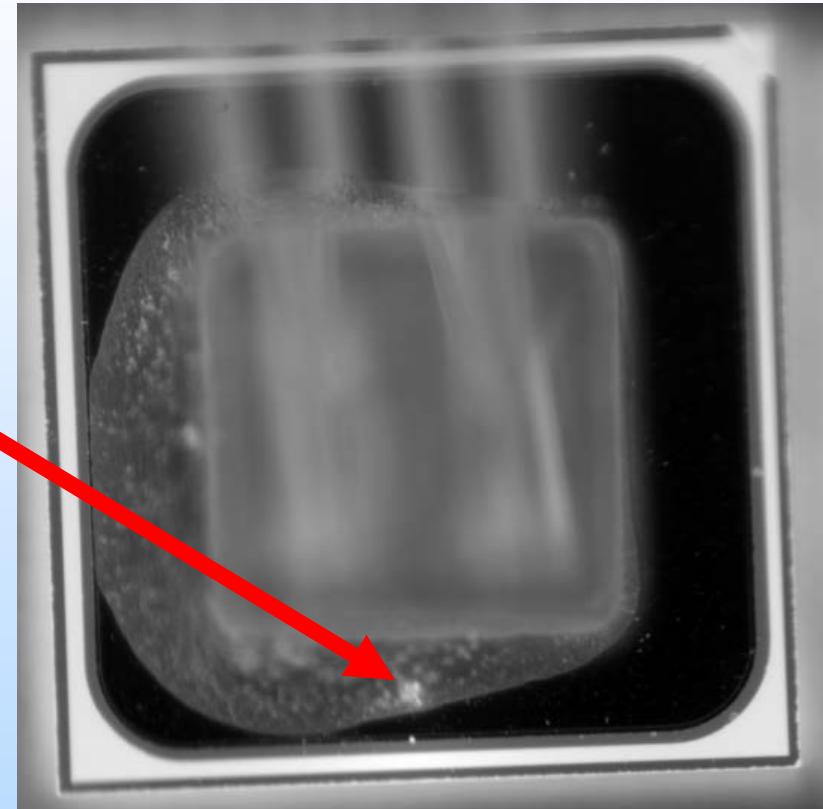
Infrared Imaging of DUT

- Diode was examined using an IR camera and pictures were taken with a small voltage applied
 - Bright white spot just below the wirebond contact is the location of the failure
- Low-magnitude and high-magnitude optical images of the surface of the DUT did not show anything unusual at the location identified in the IR image

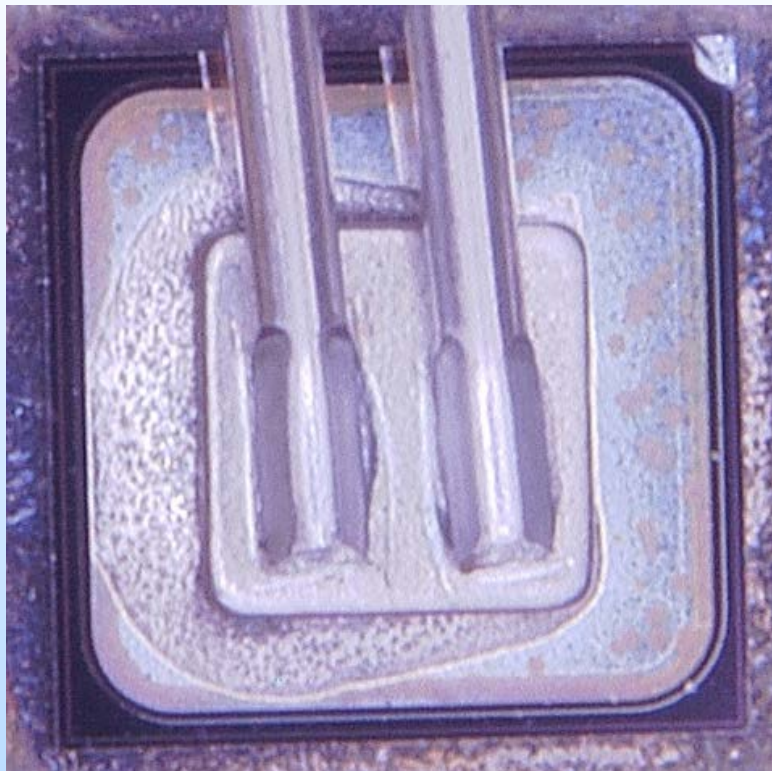
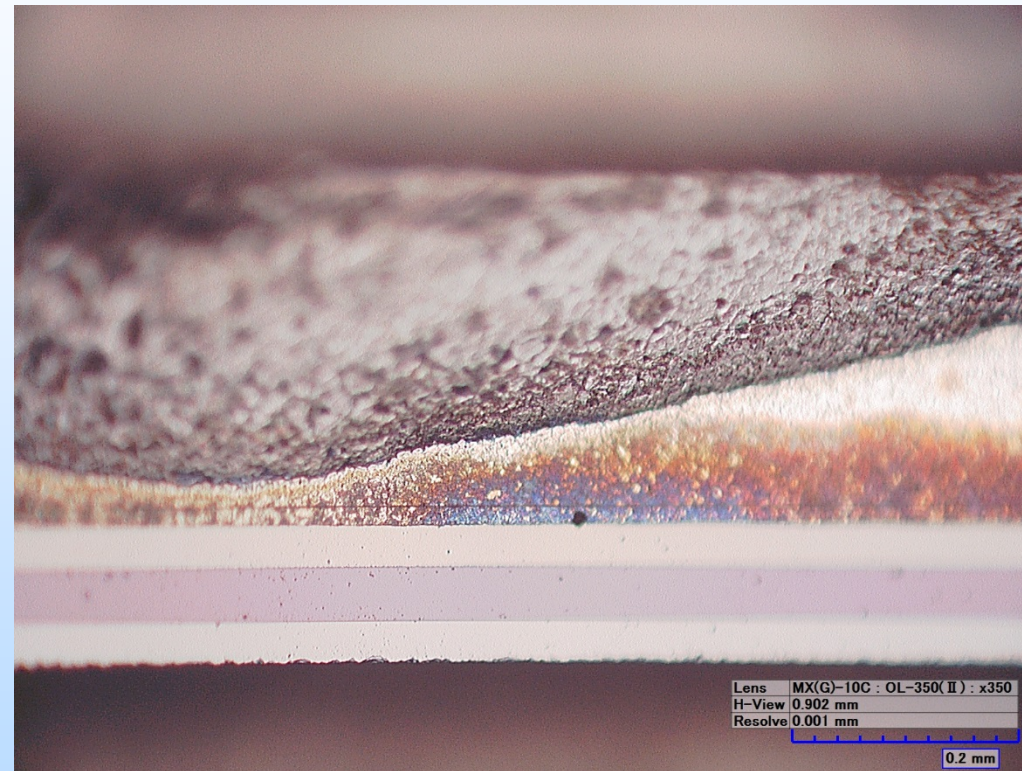
Optical Images of DUT

Failure location is not visible in optical images

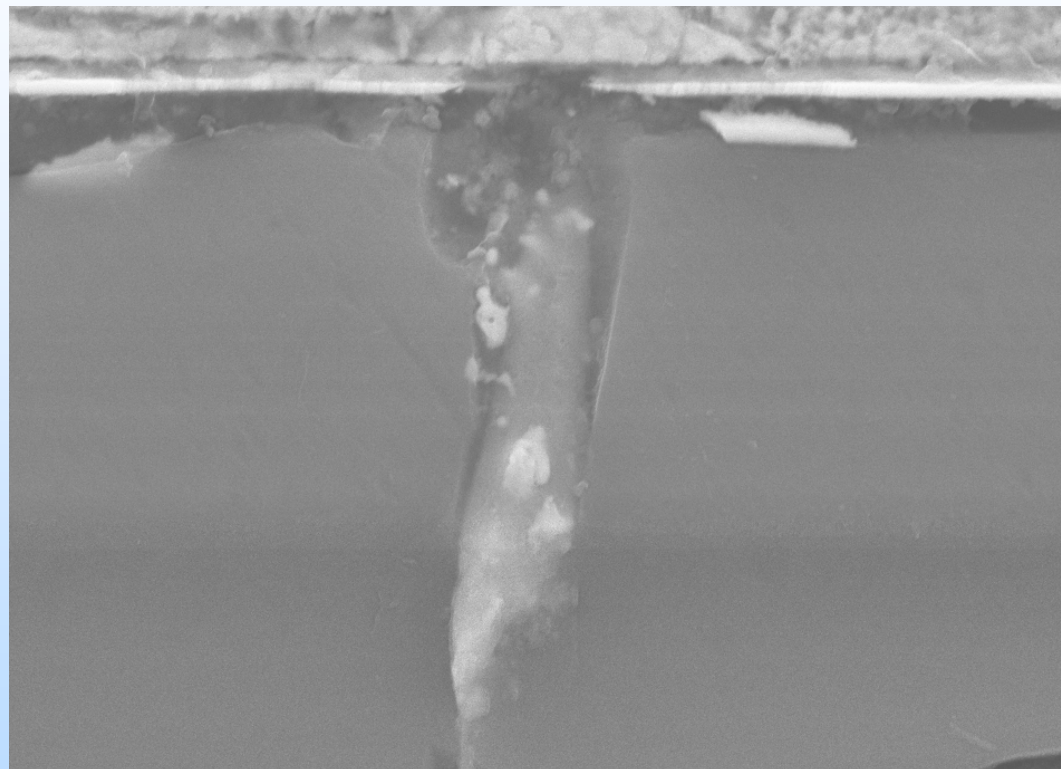
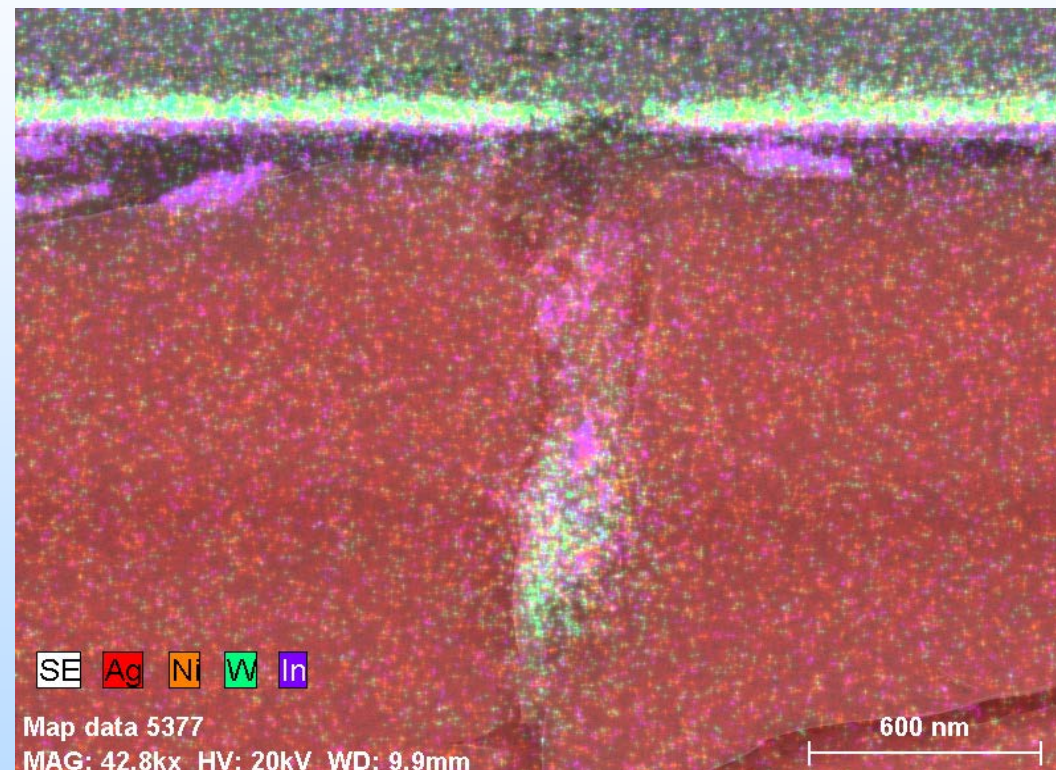
Energy Dispersive X-Ray Spectroscopy

Metal has clearly displaced from Schottky junction into void
formed from high current

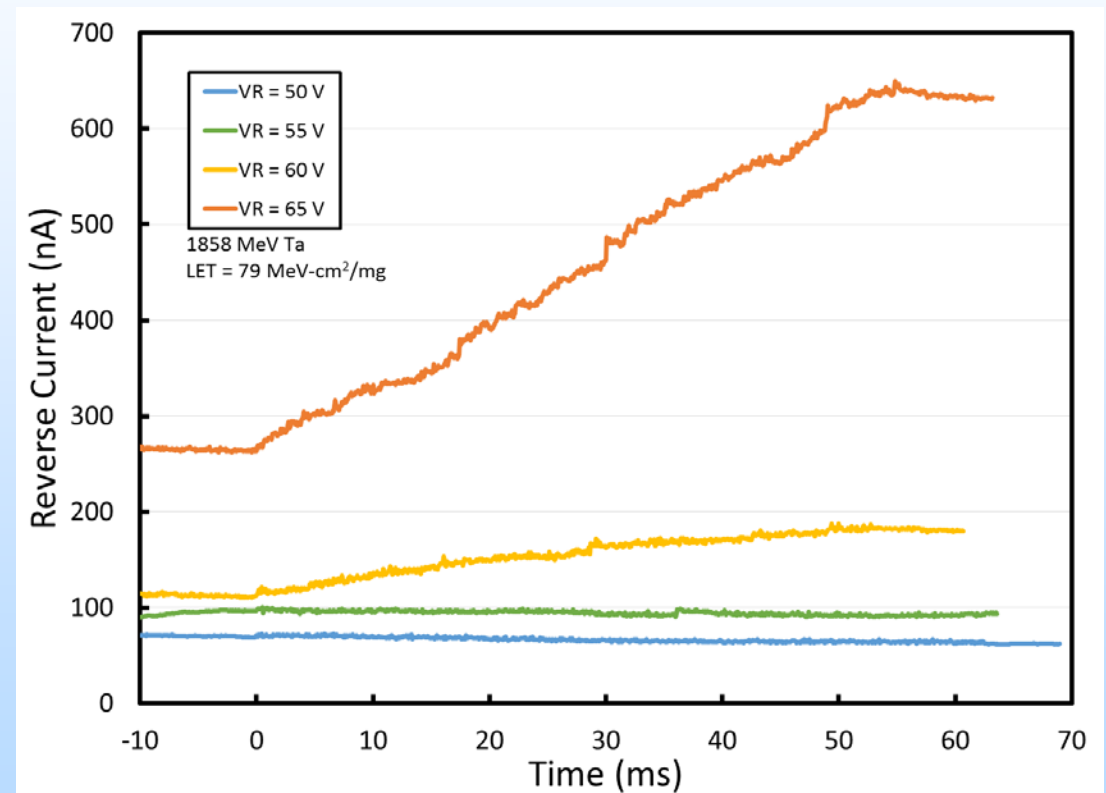
- SN2 was irradiated with 1858 MeV Ta (LET = 79 MeV-cm²/mg) in 5 V steps starting at 50 V (50% of the rated reverse voltage)
- Only charge collection was observed up to the 55-V irradiation
- When biased at 60 V, a ~60 nA increase in I_R was observed
 - All post-irradiation parameter measurements remained within specification
- At 65 V, however, DUT experienced 100s of nA in degradation and post-irradiation I_R measurement was out of specification

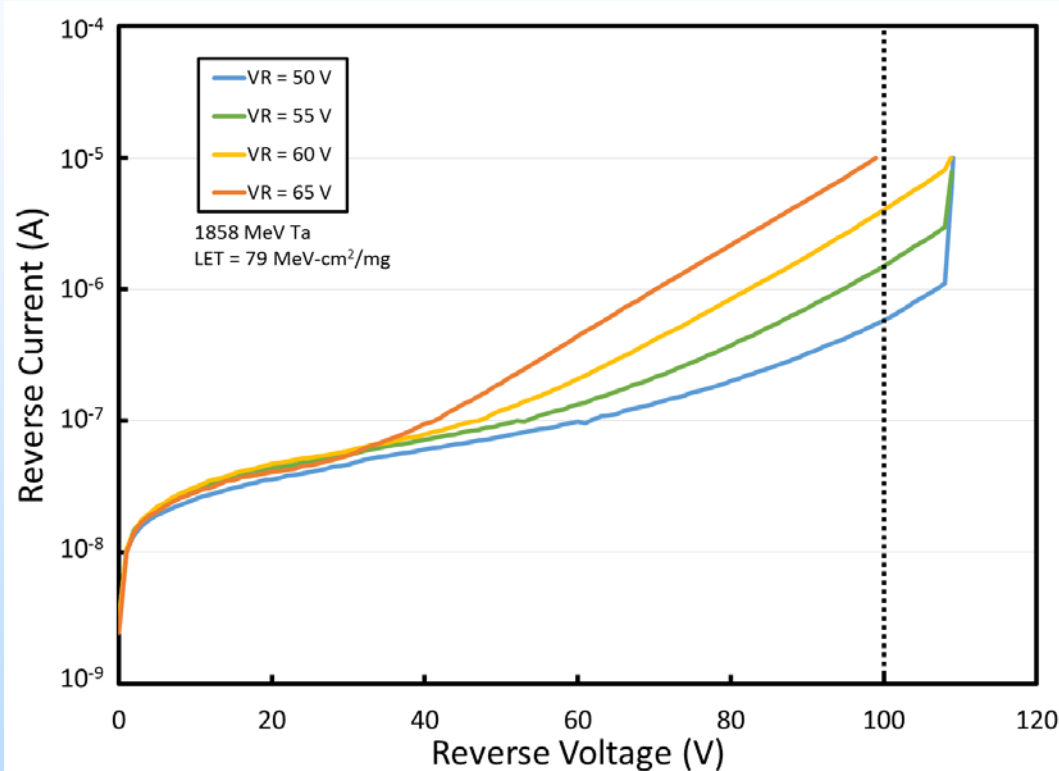
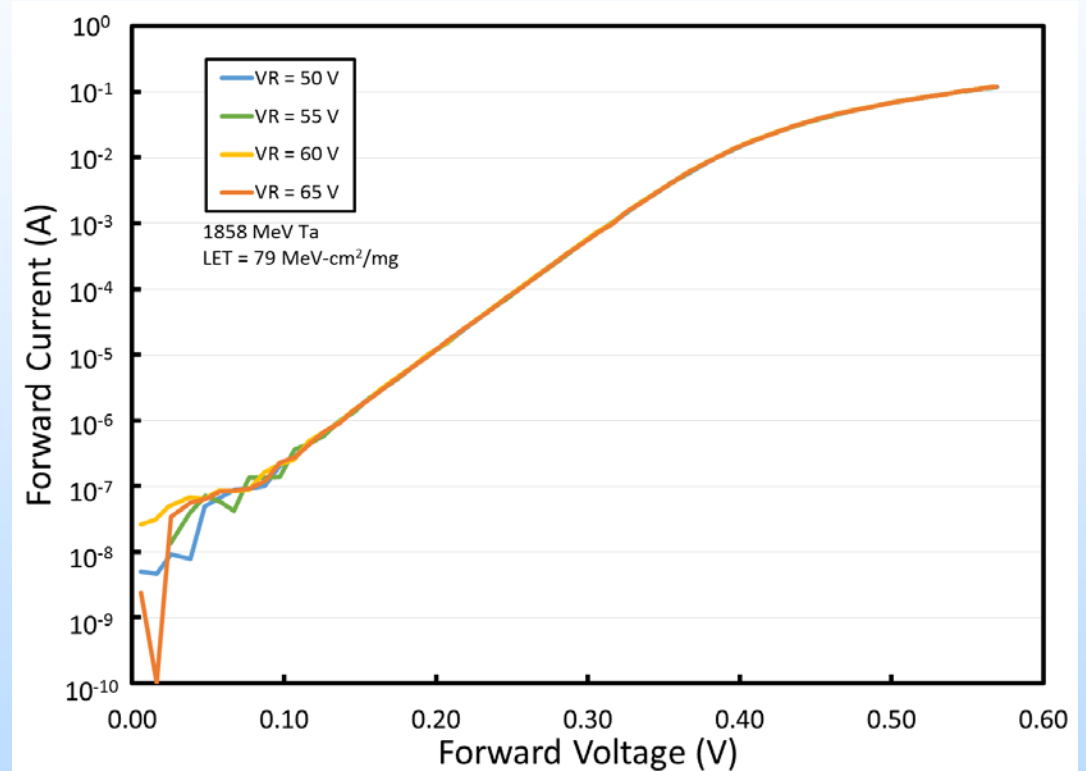
No significant changes were observed in the I_F - V_F curves, but I_R exceeded specification at less than 100 V

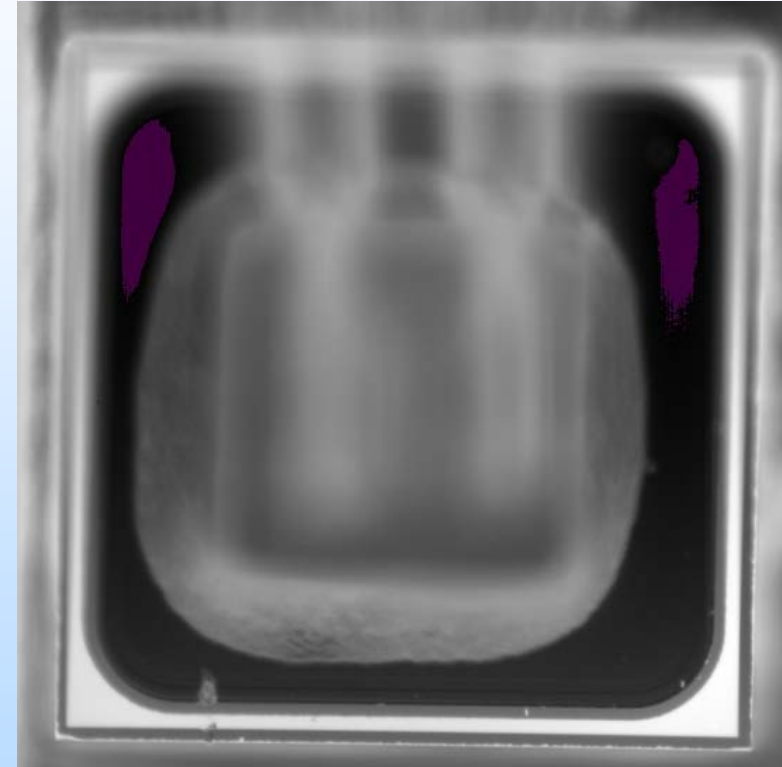
Infrared Imaging of DUT

- Diode was examined using an IR camera and pictures were taken with a small voltage applied
 - No failure locations could be identified
- Low-magnitude and high-magnitude optical images of the surface of the DUT also did not show anything unusual
- Because no failure locations were identified, a different technique had to be used
 - A series of chemical etches were used to remove the contact pad, solder connection, and Schottky barrier metal

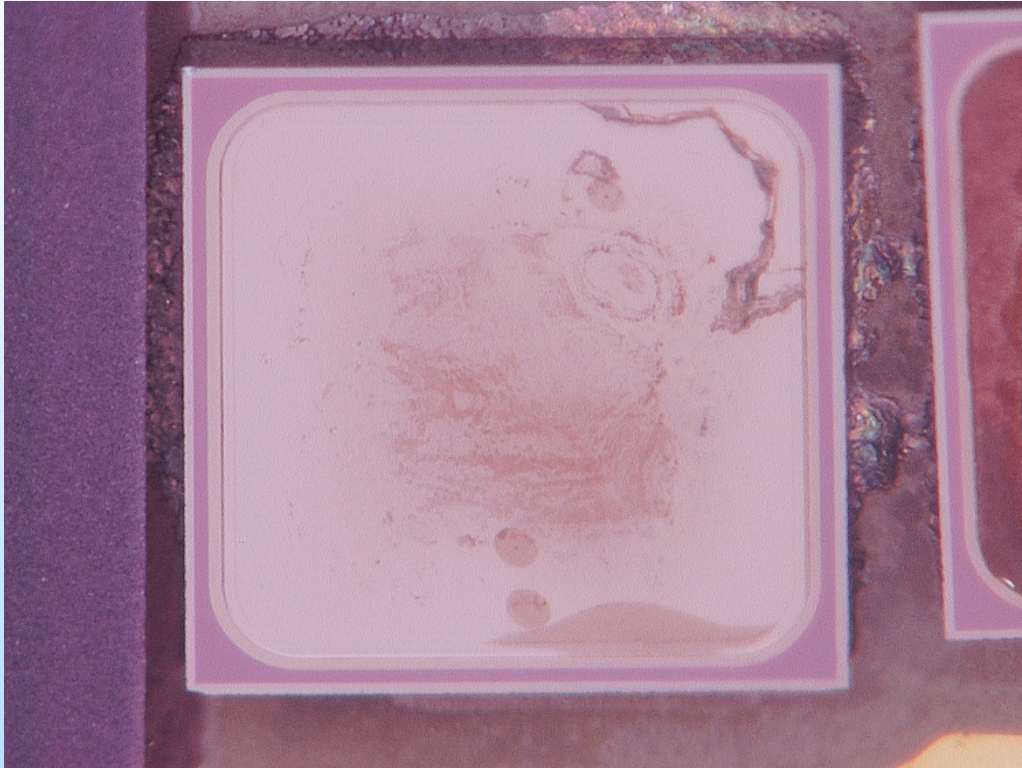
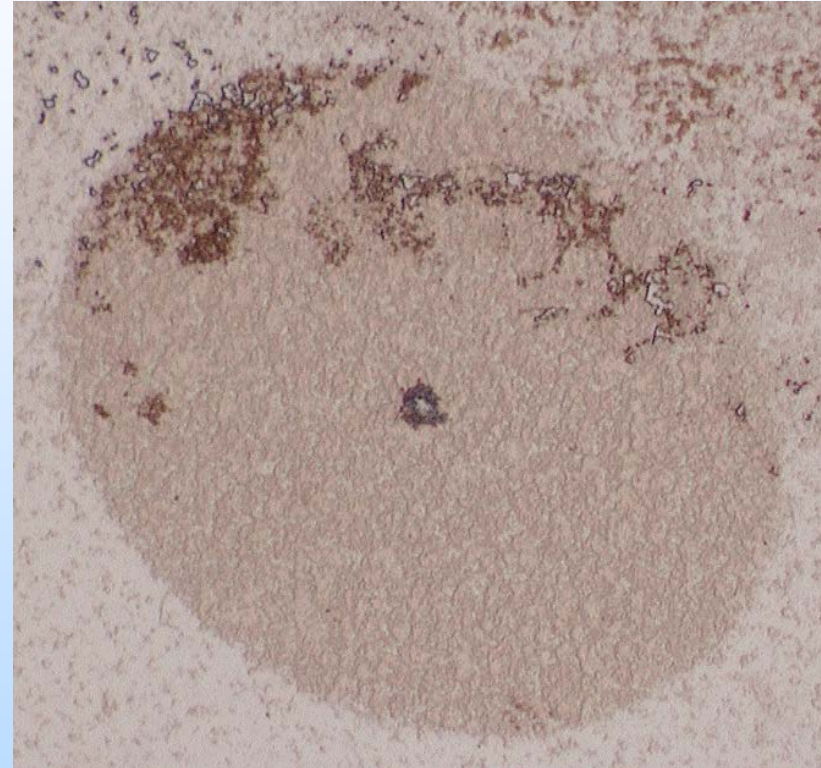
Optical Images of DUT

After chemical etches, a few small discolored locations were identified with displaced silicon at the center

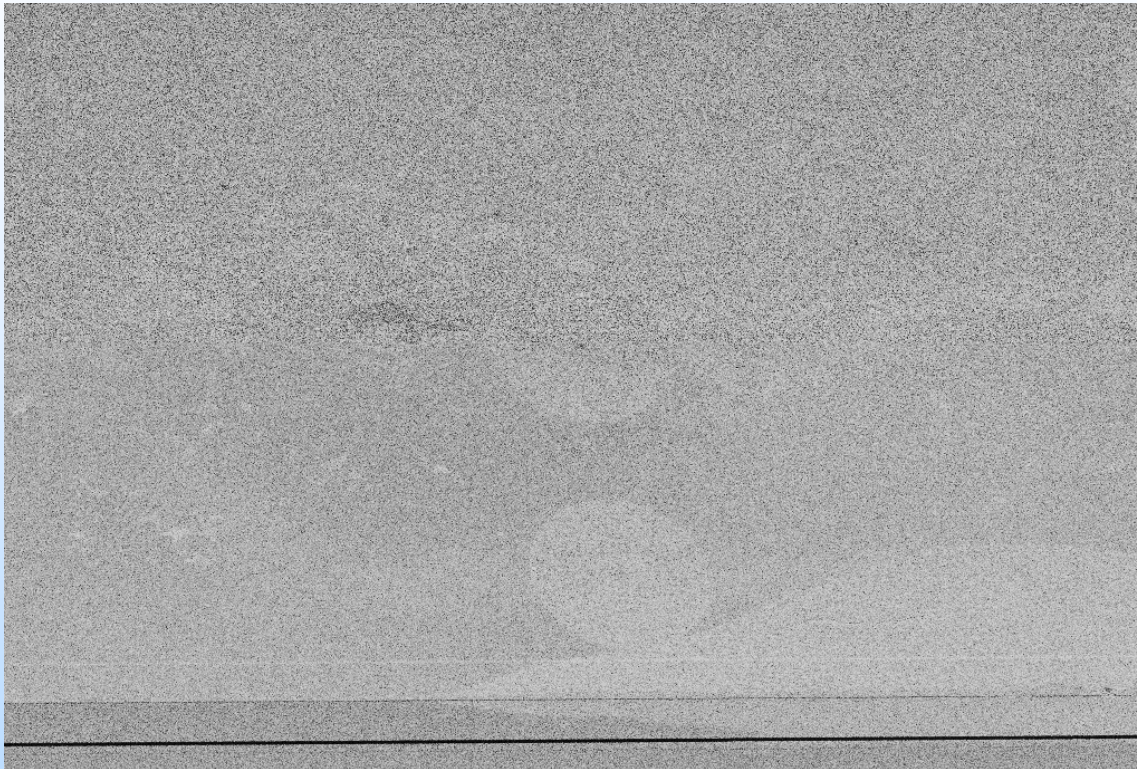
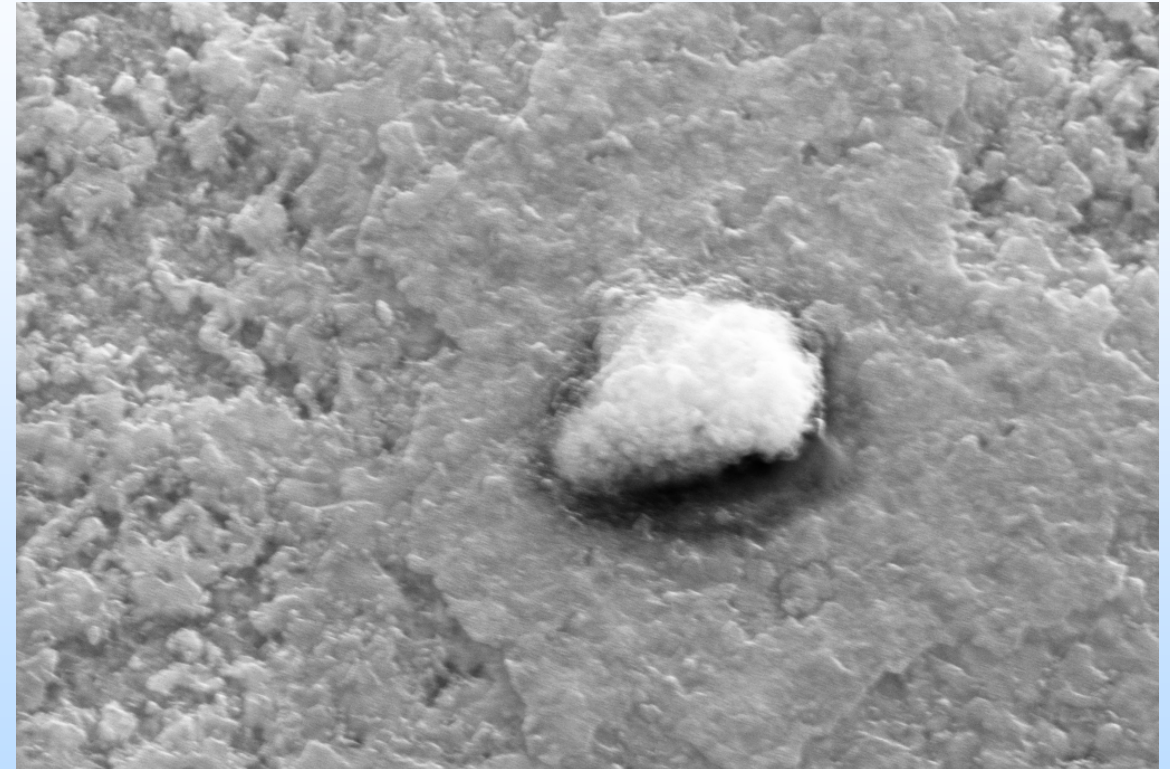
Scanning Electron Microscope Images

Displaced silicon ball was unable to be removed from surface
of the diode

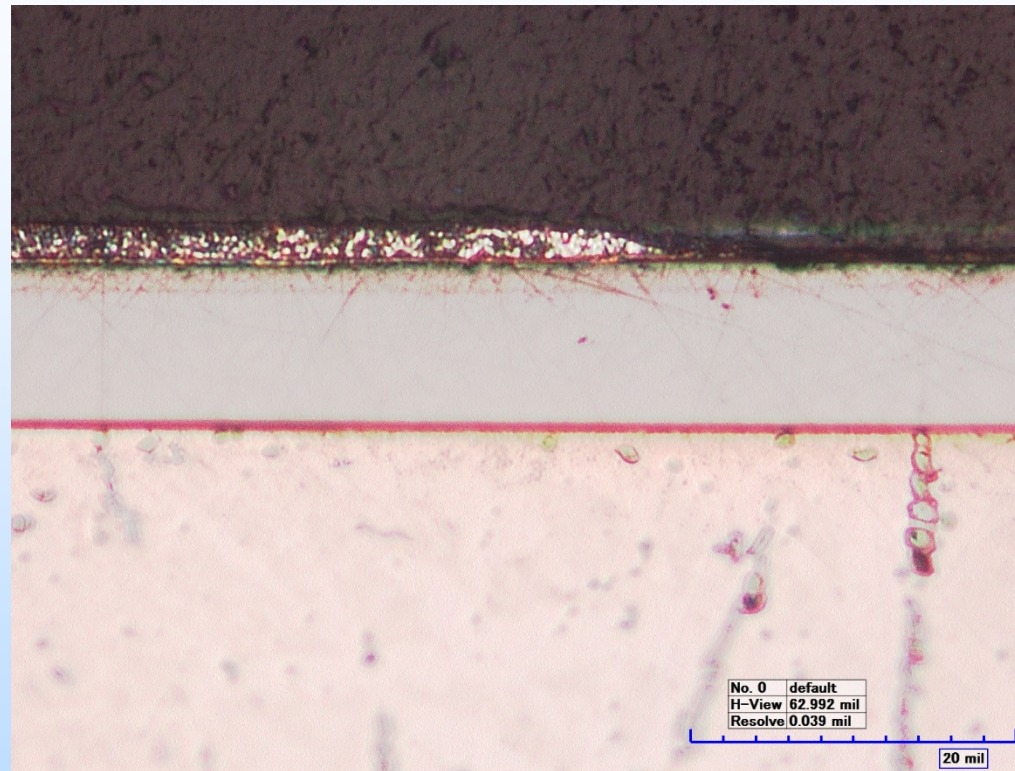
Cross-Section at Displaced Silicon Location

There is no damage structure visible in the damaged diode cross-section

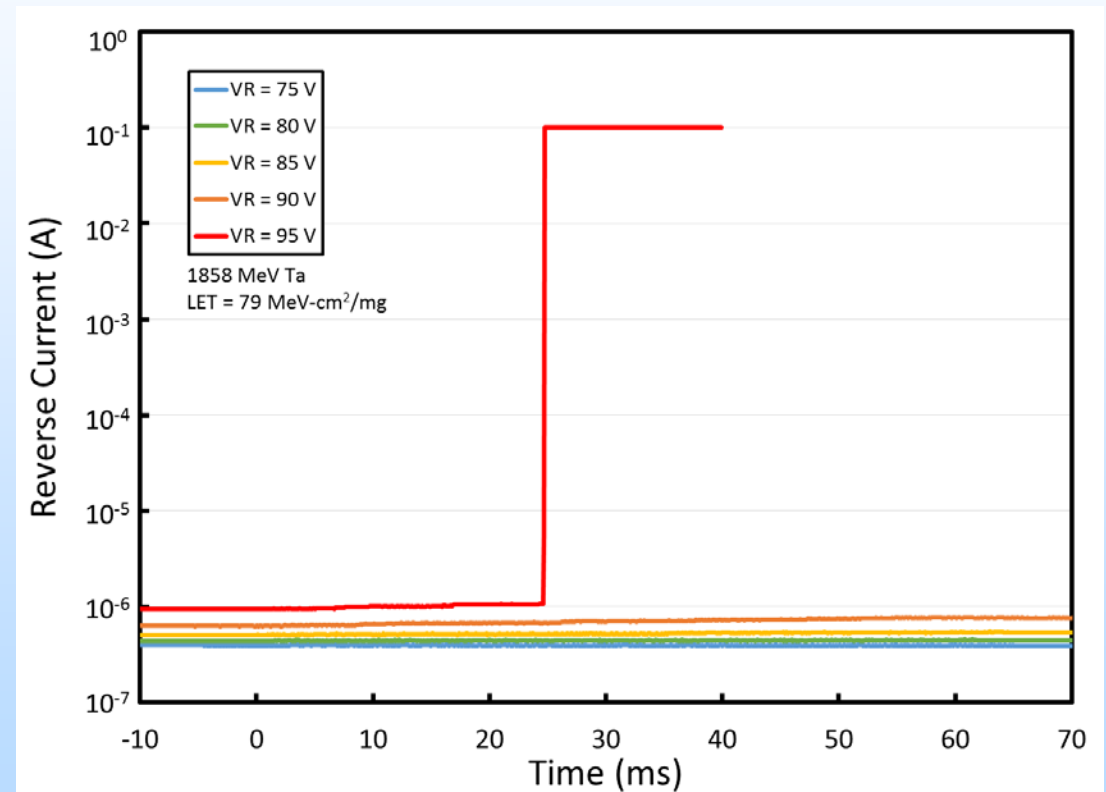
- SN7 was irradiated with 1858 MeV Ta (LET = 79 MeV-cm²/mg) in 5 V steps starting at 75 V
- Only charge collection was observed up to the 85-V irradiation
- When biased at 90 V, a ~140 nA increase in I_R was observed
 - All post-irradiation parameter measurements remained within specification
- At 95 V, the current reached the maximum 100 mA allowed by the power supply, and the anode and cathode were shorted together

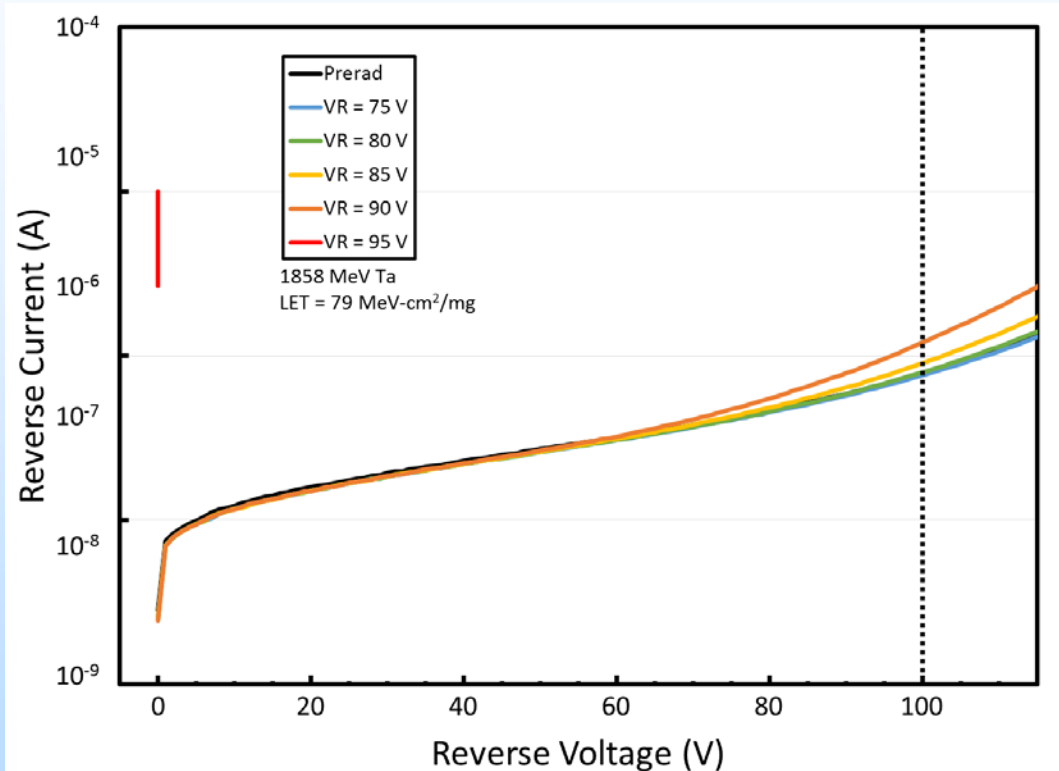
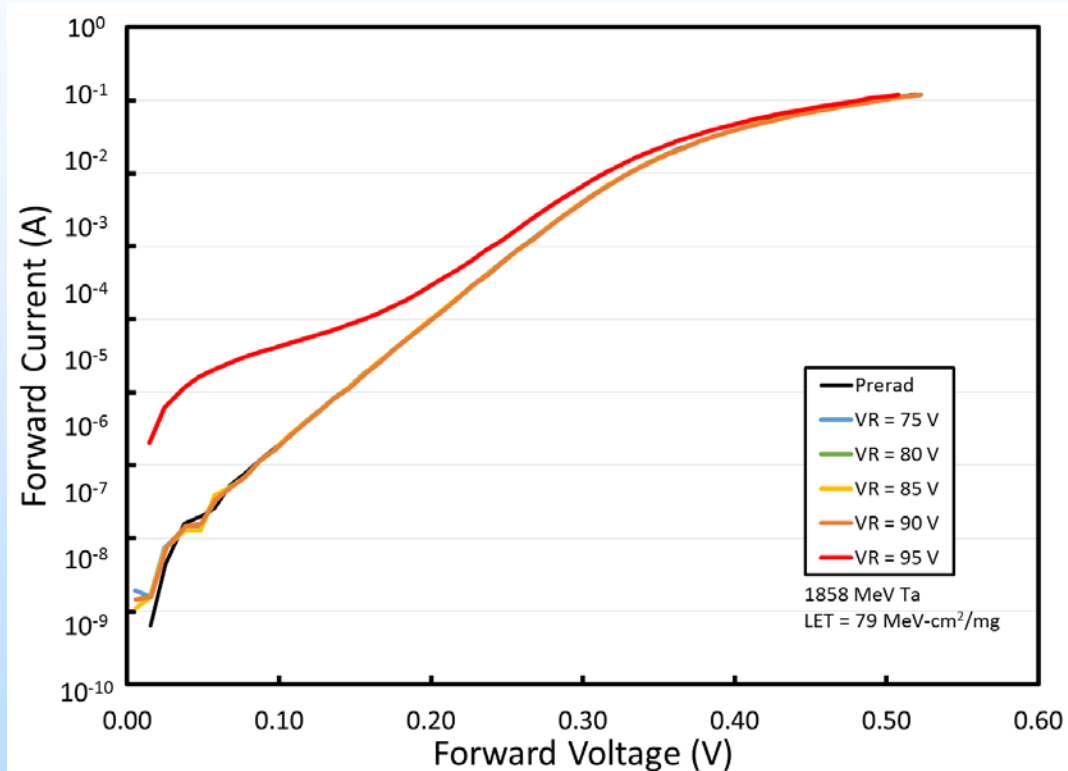
Almost no change was observed in the I_R - V_R or I_F - V_F plots until the 95-V irradiation, and then I_R exceeded 10 μ A at less than 1 V

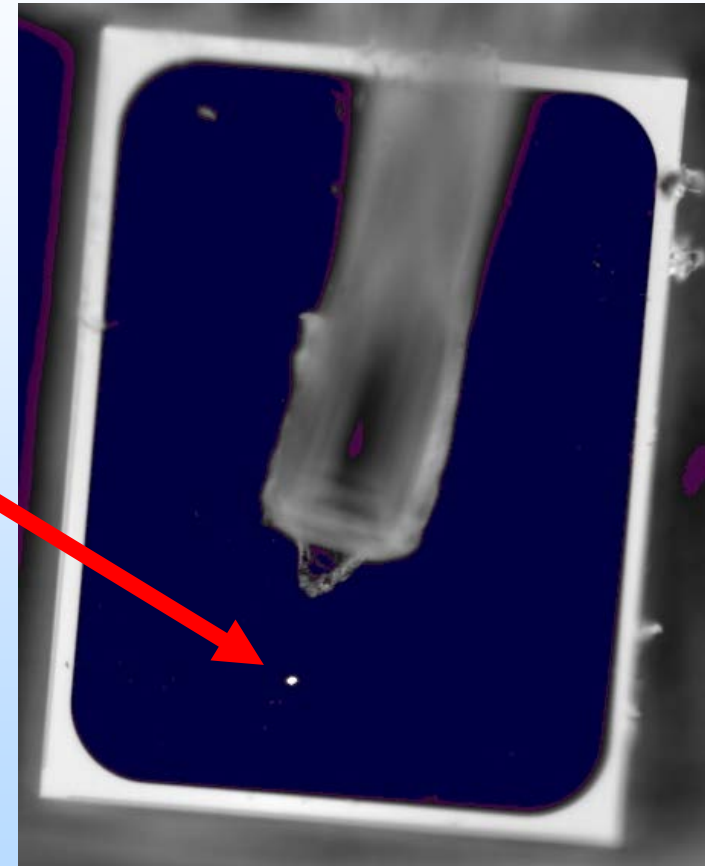
Infrared Imaging of DUT

- Diode was examined using an IR camera and pictures were taken with a small voltage applied
 - Bright white spot just below the wirebond contact is the location of the failure
- Low-magnitude and high-magnitude optical images of the surface of the DUT did not show anything unusual at the location identified in the IR image

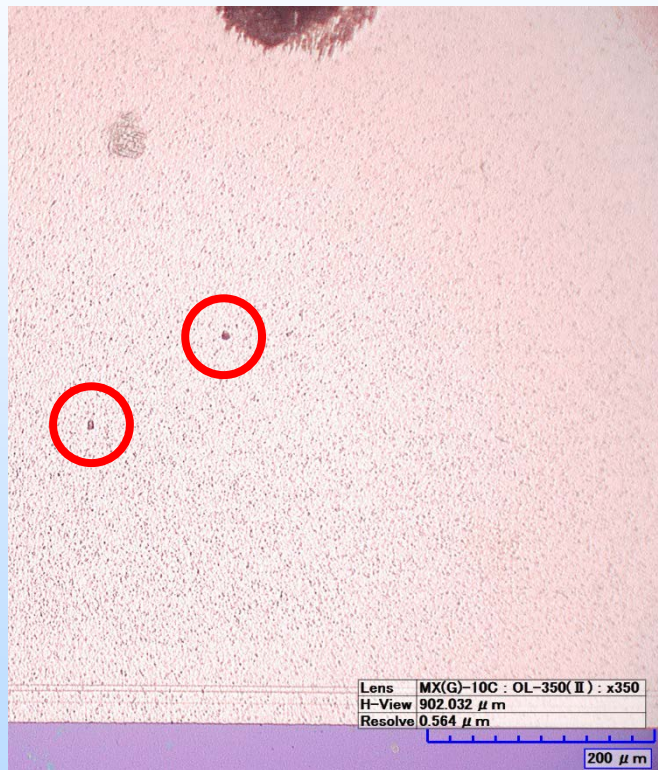
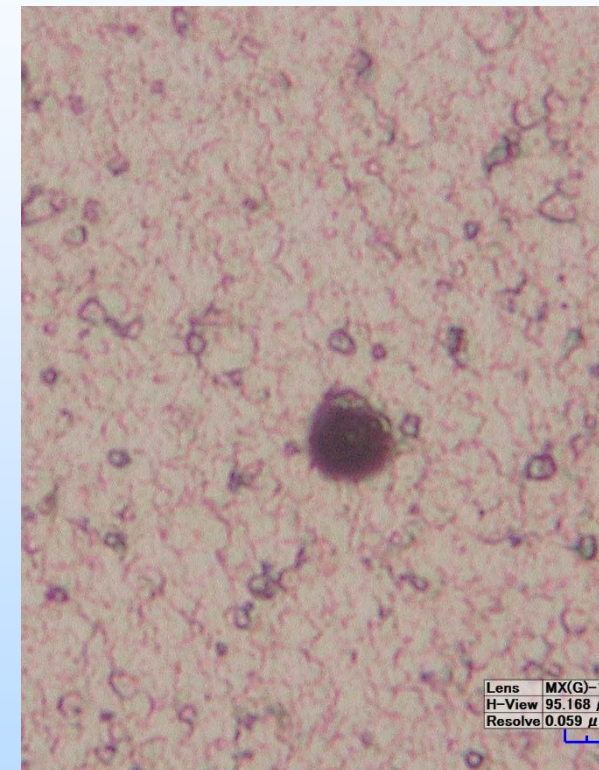
Optical Images of DUT

Unlike other part that experienced catastrophic failure, location is visible in high-magnification optical images

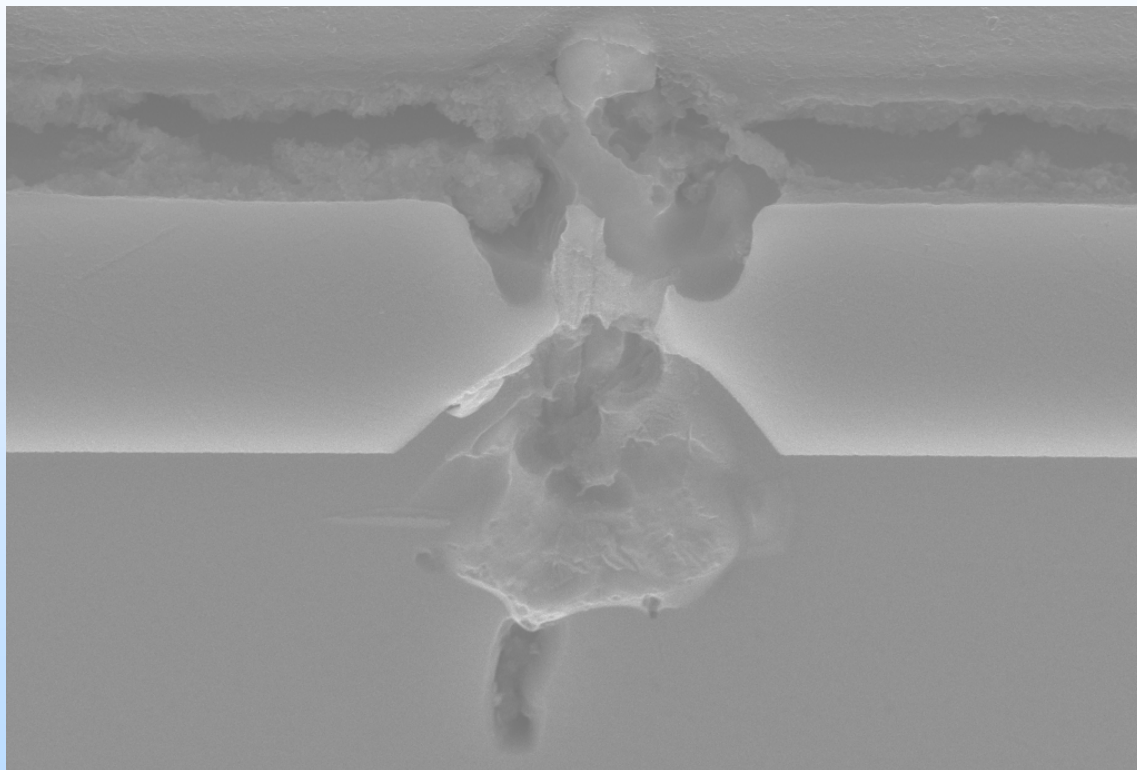
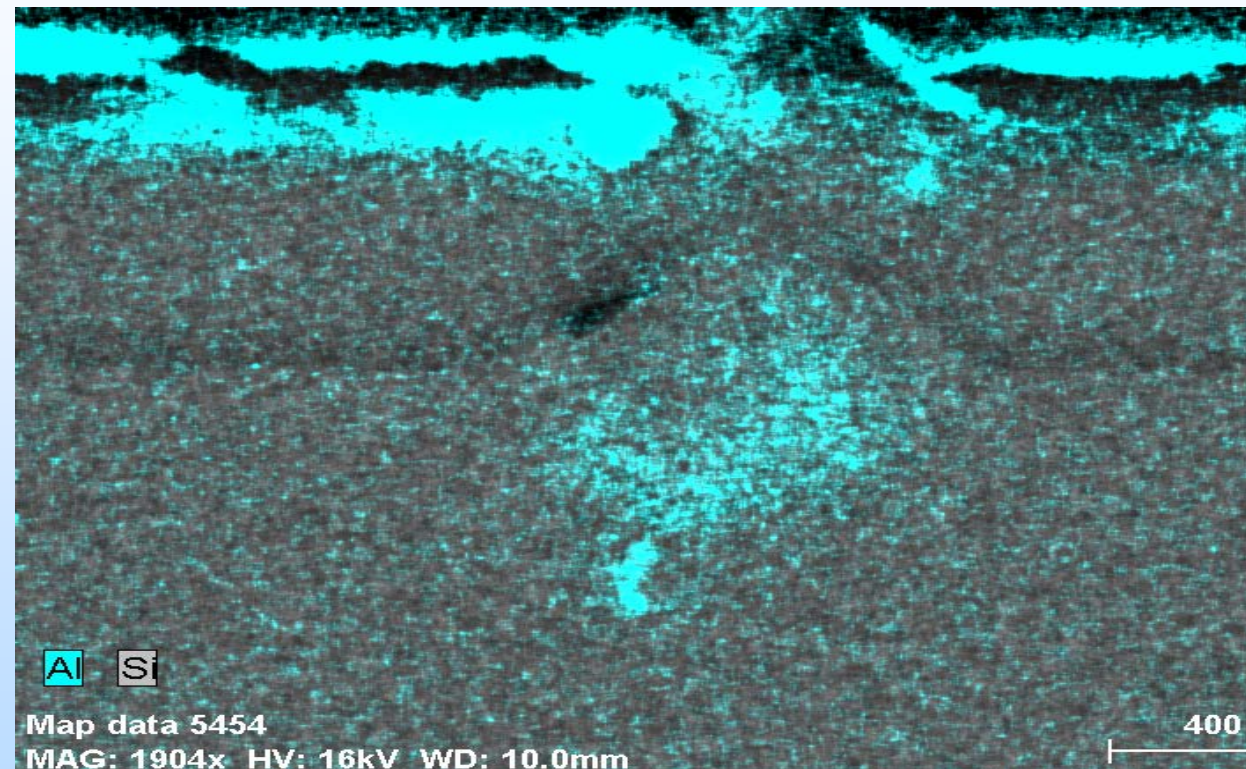
Energy Dispersive X-Ray Spectroscopy

Metal has clearly displaced from Schottky junction into void
formed from high current

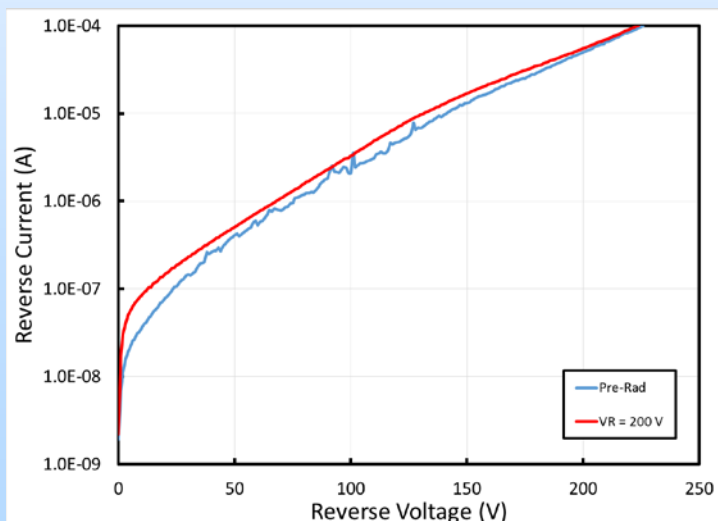
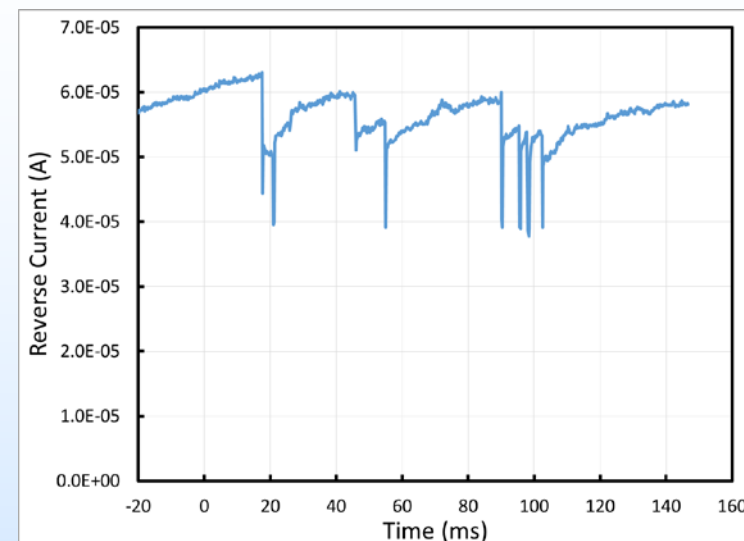
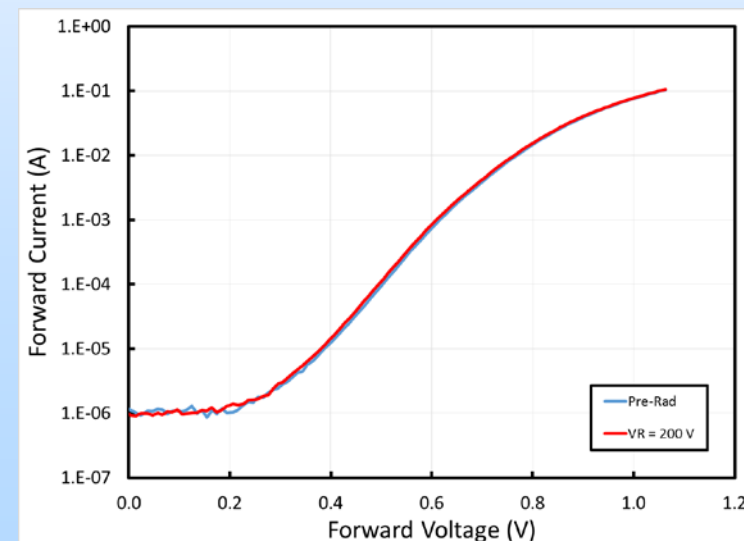
Diodes, Inc. BAS21-7-F Switching Diode

- Small changes in the reverse current were observed during the runs in which these parts were biased at the full-rated 200-V reverse voltage
- Small changes in the I_R - V_R and I_F - V_F plots were observed after the runs
 - How these changes effect the long-term reliability of the parts is unknown
